Manhole Inspection Summary

Manhole # S33UU1019MH

Insp Date: **1/29/07 12:22 PM**

Location Address: **216 GOODALE RD**

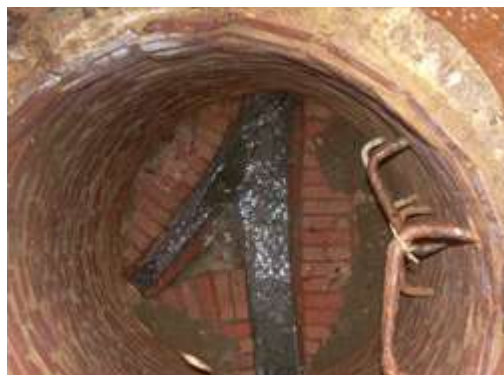
Top View

Corroded steps. Evidence of surcharge - Bench debris. Channel debris.

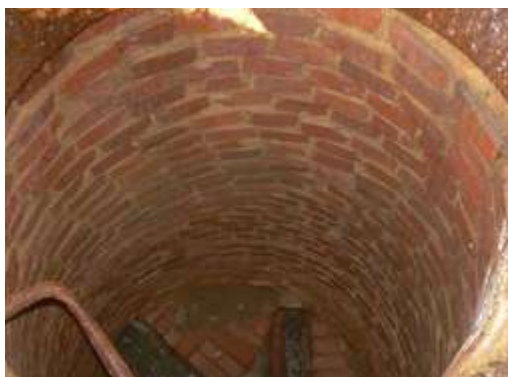
Defect

Frame leaks. Adjustment deterioration and infiltration. Barrel infiltration - other side.

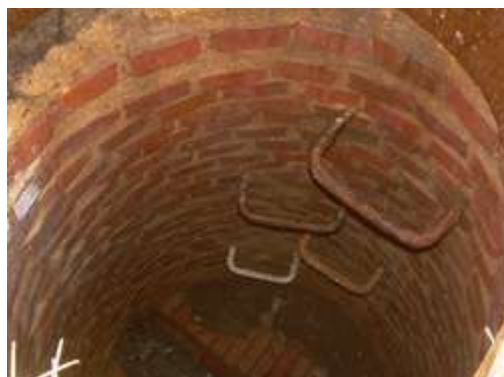
Defect

Frame leaks. Adjustment deterioration and infiltration. Barrel infiltration.

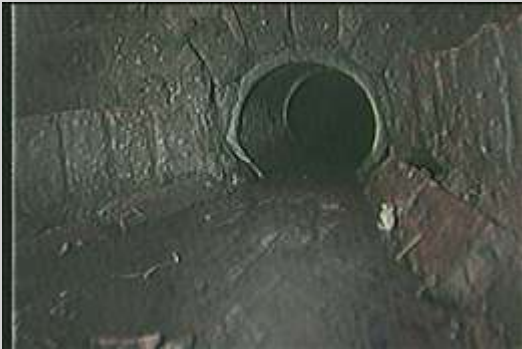
8 in. Circular Gravity Sewer Pipe Out @ 12 O'Clock

Infiltration: **Evidence** Pipe Seal Cond: **Cracked**

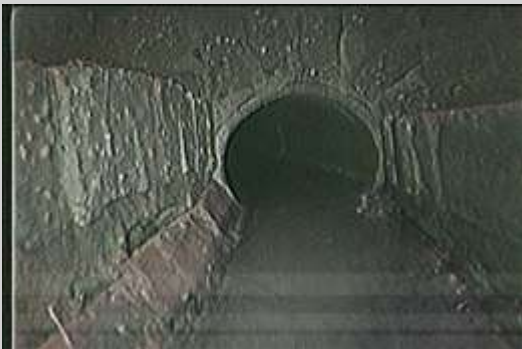
8 in. Circular Gravity Sewer Pipe In @ 6 O'Clock

Channel deterioration.

Infiltration: **None** Pipe Seal Cond: **Cracked**

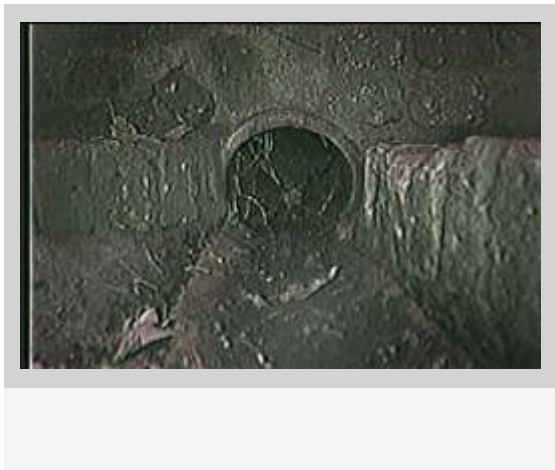
6 in. Circular Gravity Sewer
Pipe In @ 8 O'Clock

Deposits: ☐ None ☒ **Mud** ☐ Sludge ☒ **Debris** ☐ Grease

Silt Depth: **0** (in.) Deposits Extent: **Light**
